Wanapum Dam, Tainter Gate 1, Left Bank Hoist Chain Failure

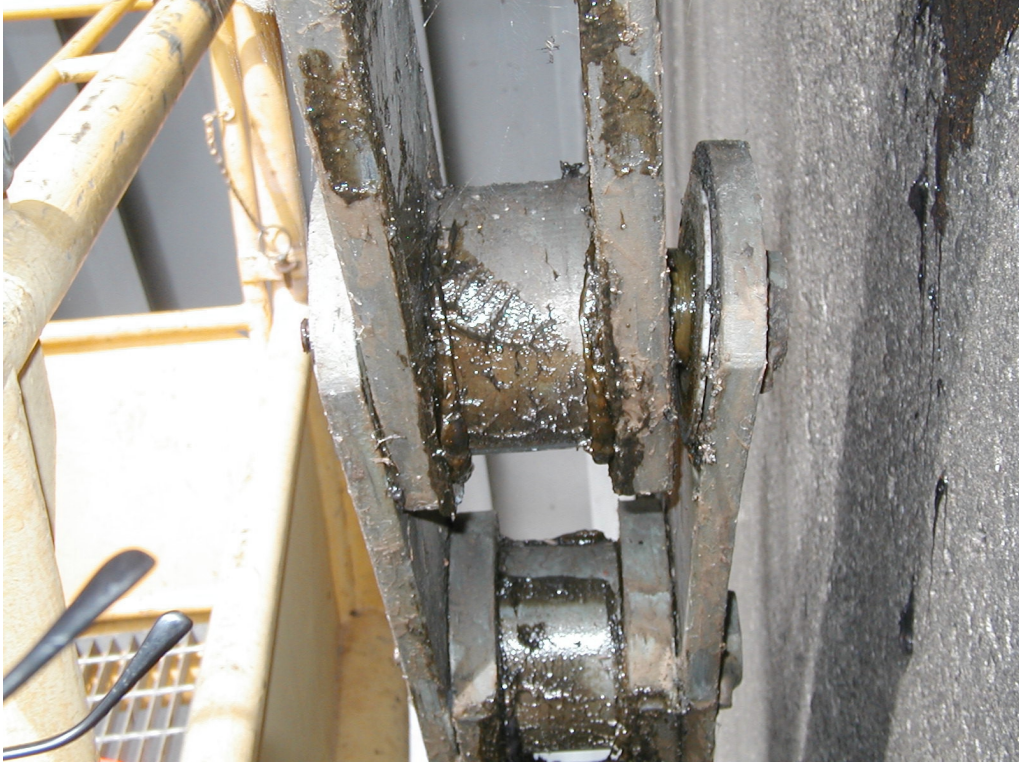
Roller pin No. 41 and the bent side plate were removed for inspection. The side plate was found to be approximately 0.010 inches out of flat. This was measured with a straight edge laid across the length of the plate and feeler gages slipped under the gap.

Photo 1: Wanapum Dam, Tainter Gate 1, left bank hoist chain bent side bar

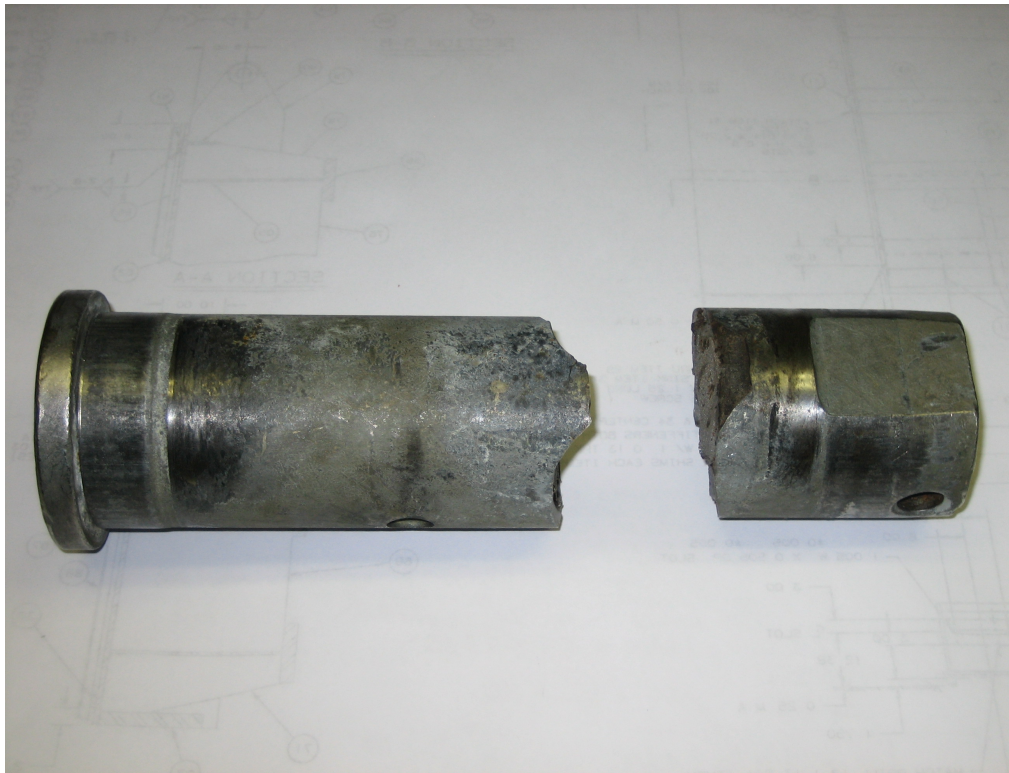
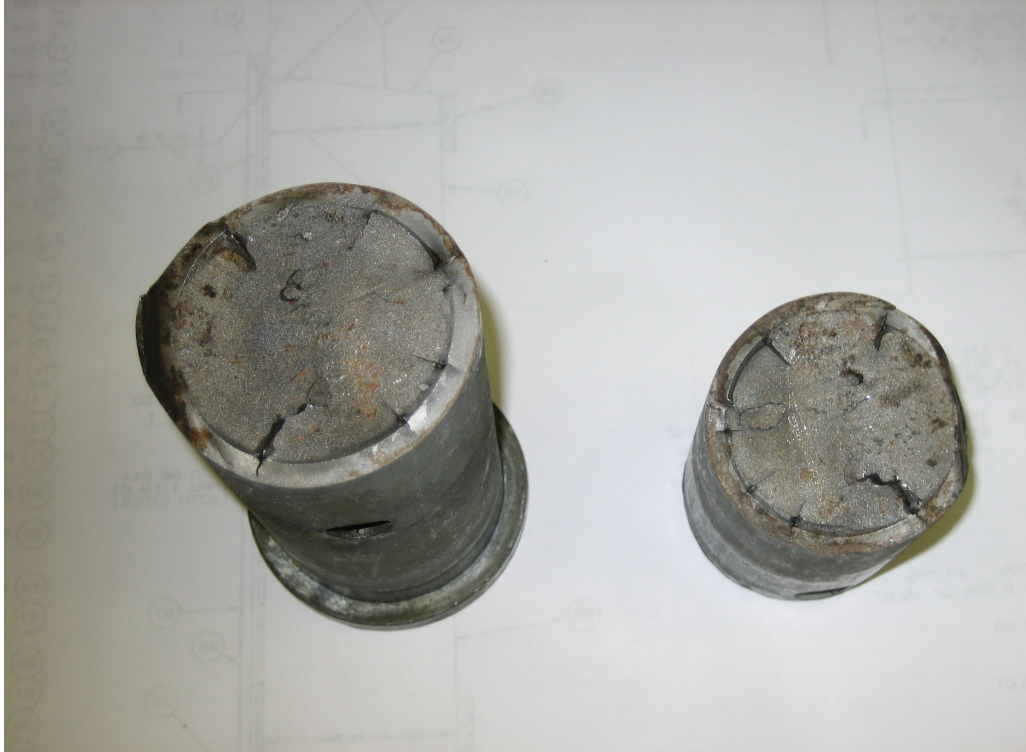
Photo 2 and 3 both show roller pin No. 41 in two pieces. The pin was pressed out of the chain without any issues. Upon initial examination, a large crack could be seen in the pin. While the pin was being cleaned it separated into the two pieces shown in the photos. Current plans are to send both pieces of roller pin 41 to an material fracture lab for examination and determination of the nature of failure.

Photo 2: Wanapum Dam Tainter Gate 1, left bank hoist chain, roller pin 41

Photo 3: Wanapum Dam, Tainter Gate 1, left bank hoist chain, roller pin 41 end view
