Wanapum Dam Incident Report, Priest Rapids Project No. 2114

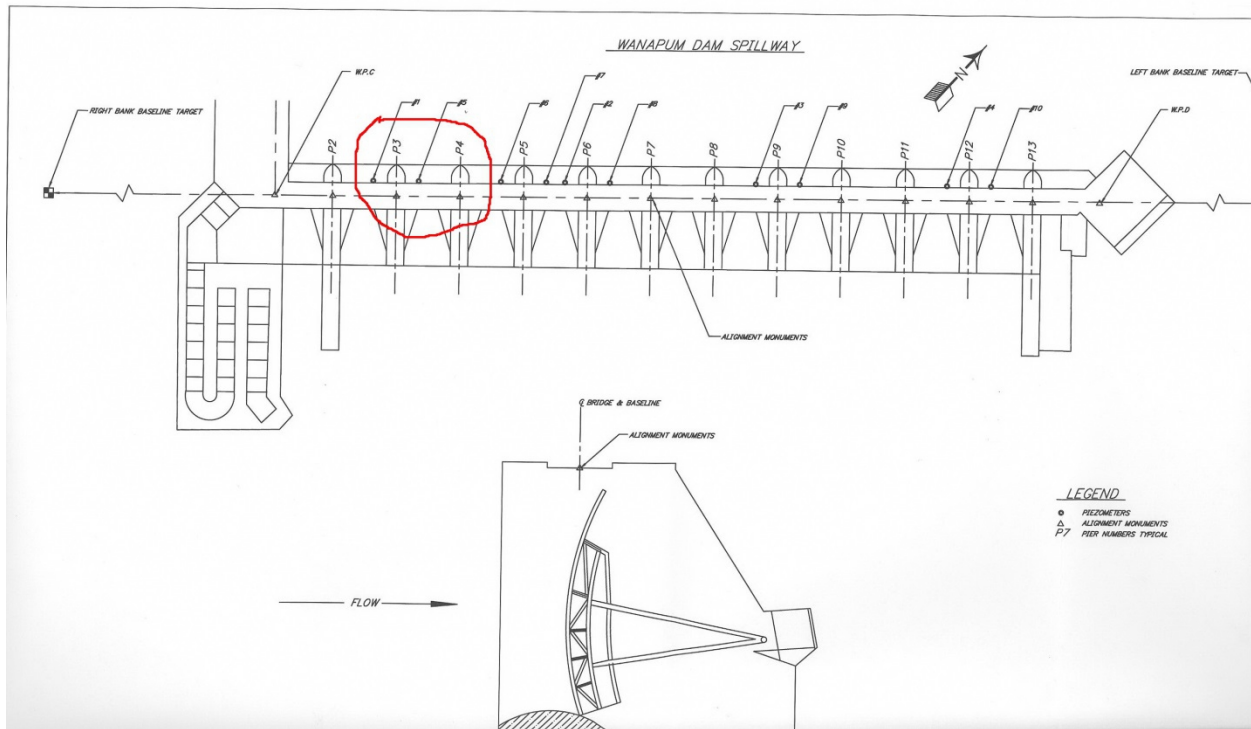
The latest DSSMR includes a plot (below) showing historical movement for piers 3 and 4. It appears that Pier 4 is moving downstream, while Pier 3 has moved upstream. This appears to indicate rotation of the spillway monolith. Since 2001, Pier 4 has shown a total movement of about 1 inch in the downstream direction. In the last couple years, Pier 3 has shown movement of 0.3 inches in the upstream direction.
