Fontenelle Dam, Ririe Dam, and Teton Dam

An Examination of Organizational Culture on
Decision-Making

Nate Snorteland, P.E.

U.S. Army Corps of Engineers

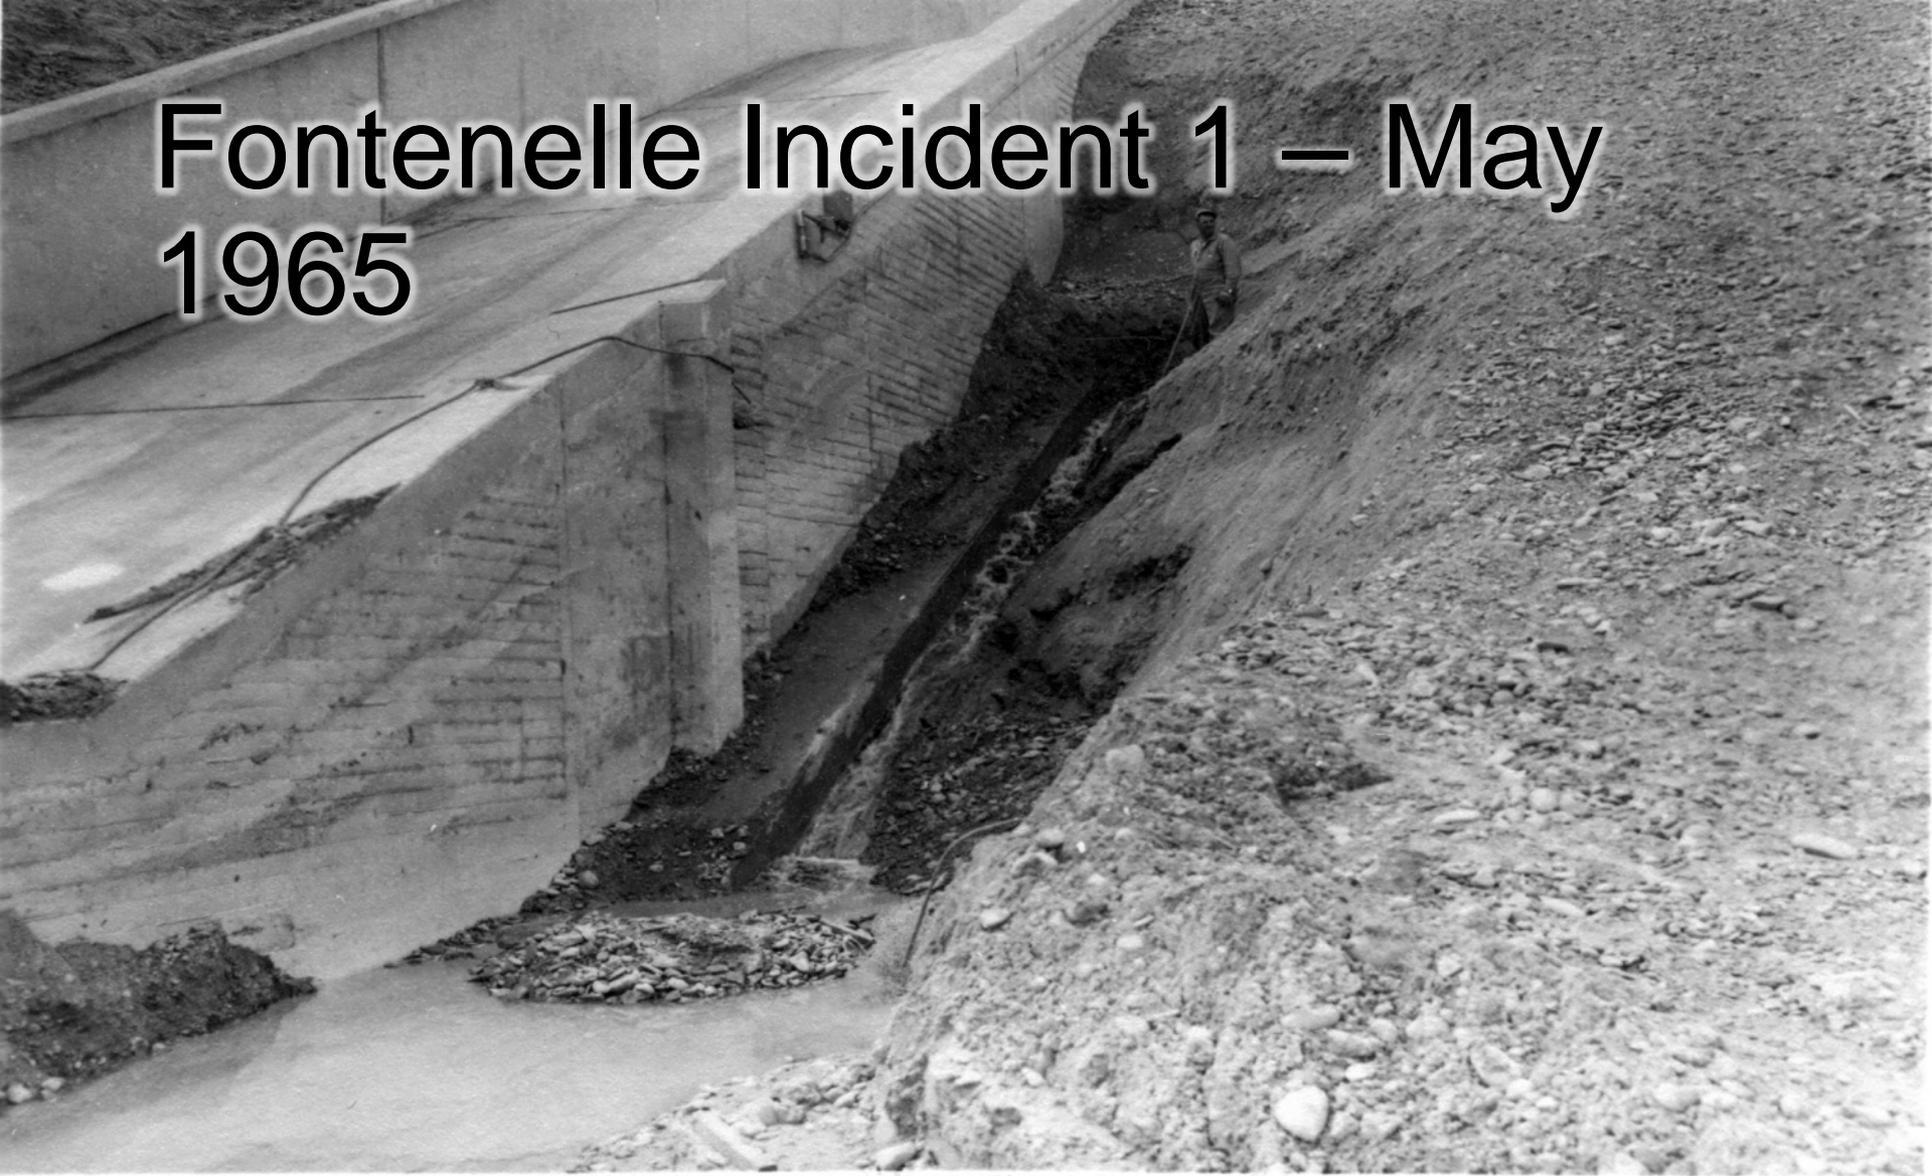
Fontenelle Incident 1 – May 1965

Figure 75: P154-428-1458 Seepage emerging from shale formation along east side of spillway chute. 5/21/65

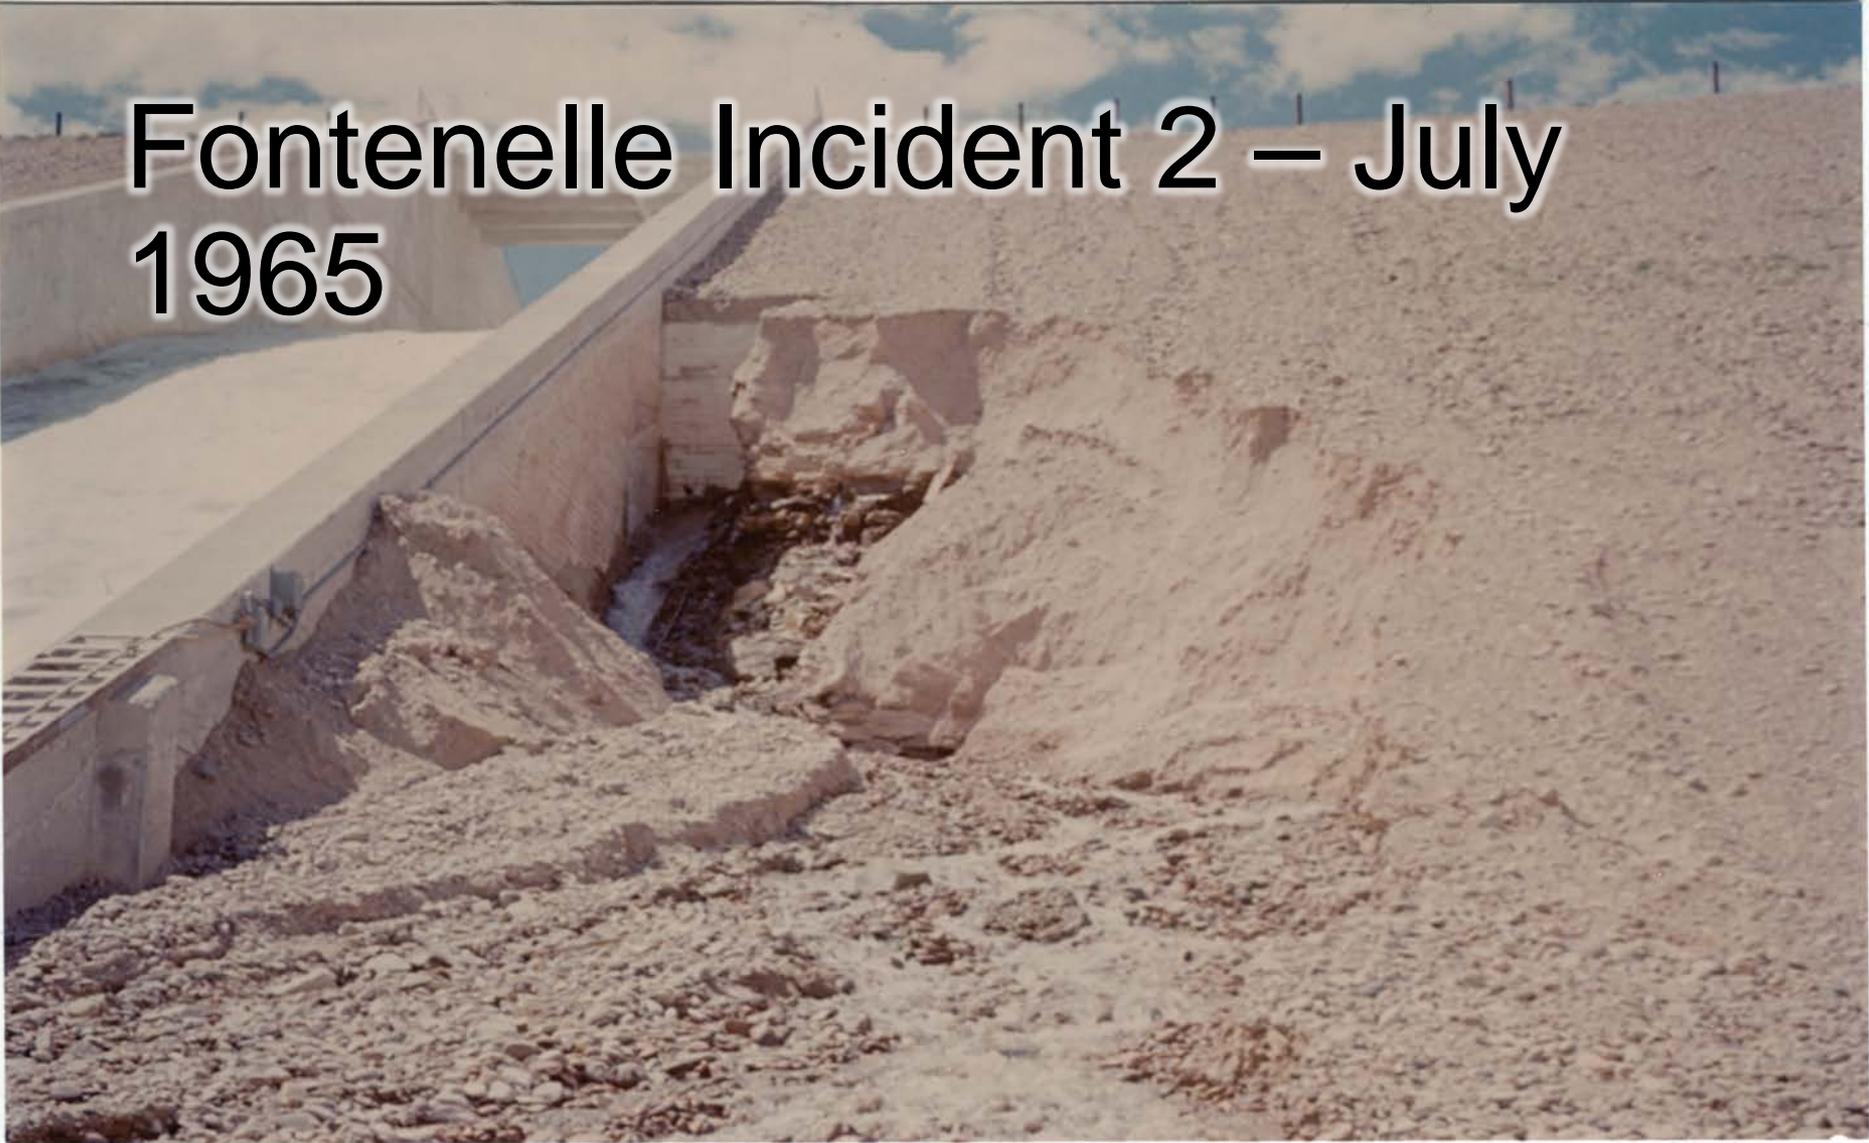
Fontenelle Incident 2 – July 1965

Photo FO-65-9 -- Fontenelle Dam. Seedskaadee Project, Wyoming, USBR July 28, 1965 -- Slide in the gravel backfill adjacent to the left spillway chute retaining wall. Seepage exits are in the center of the photograph.

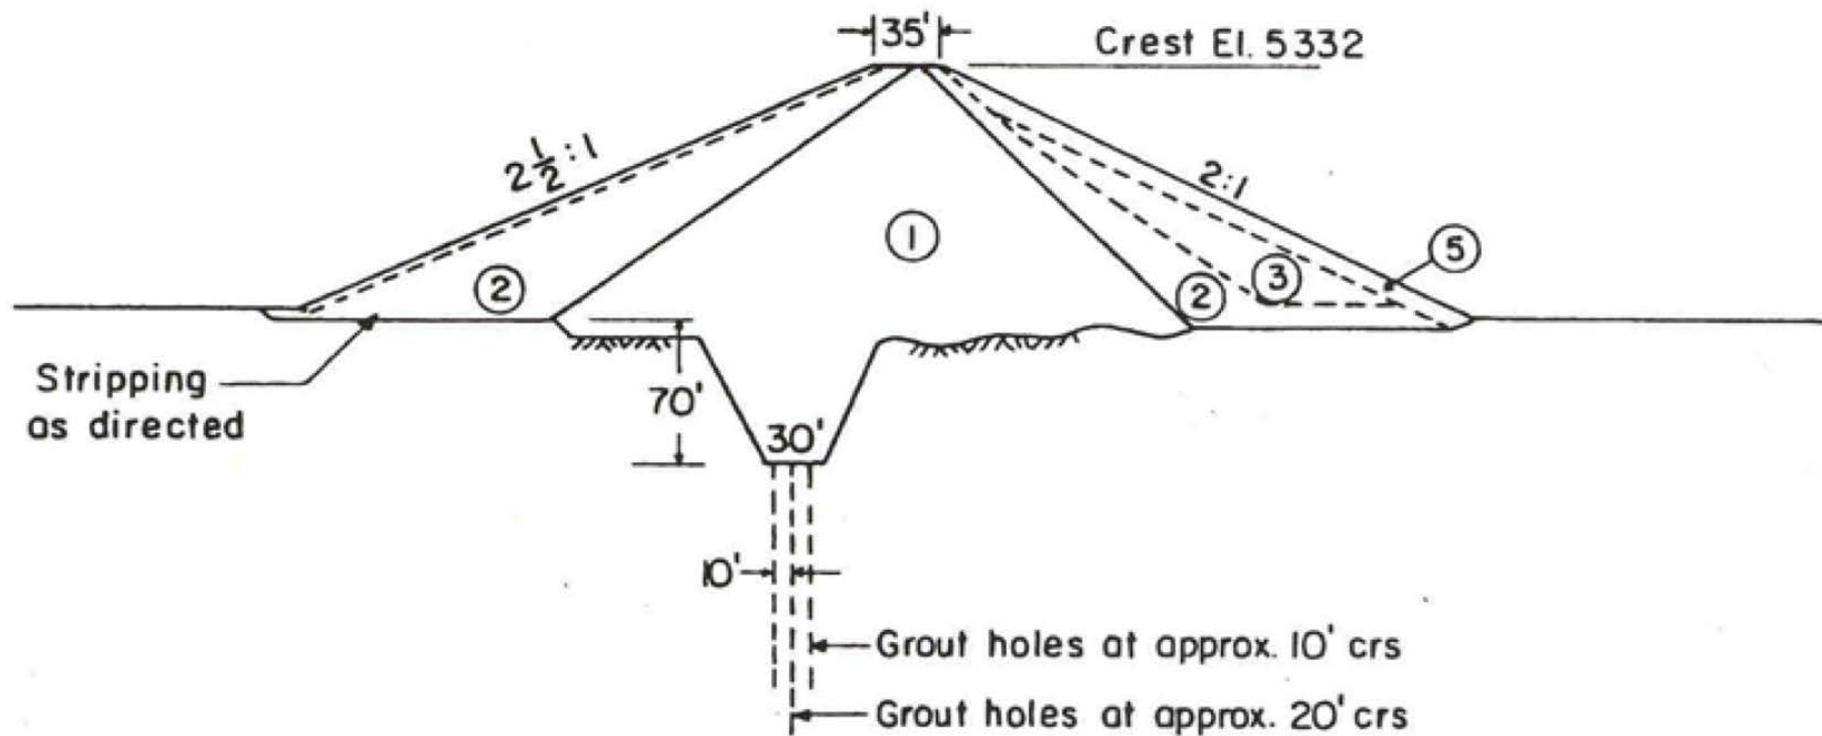
Teton Dam Right Abutment Section

Fig.3. Typical cross-section over abutment sections founded on jointed rhyolite.
