Wanapum Dam Incident Report, Priest Rapids Project No. 2114

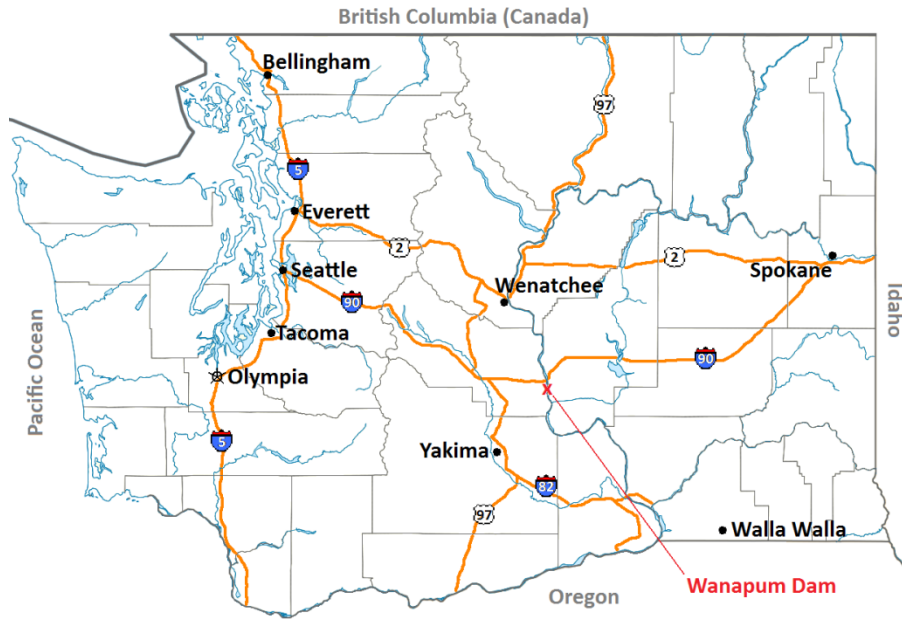
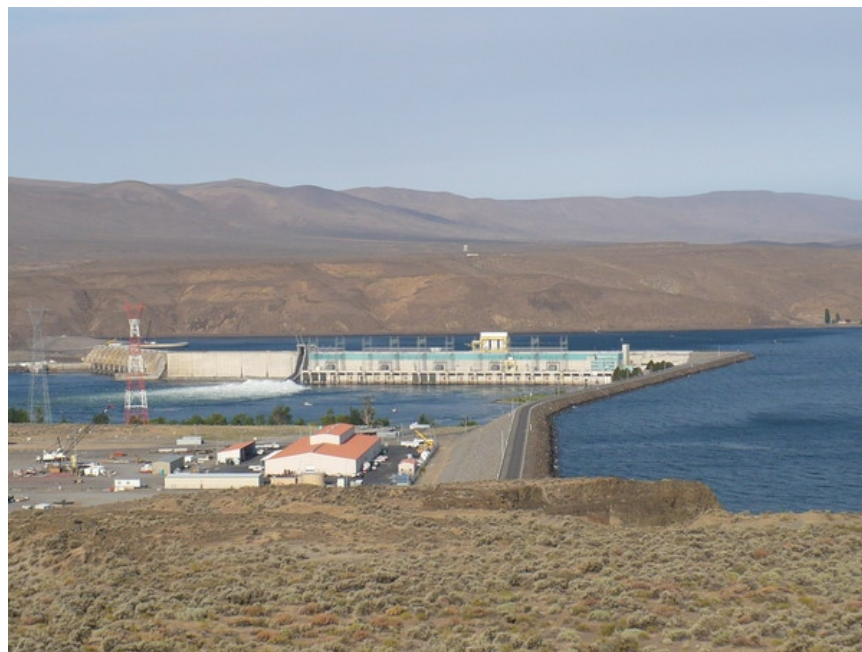
Following the discovery of movement at Pier 4 between Gates 3 and 4 on February 25, 2014, an in-depth investigation and evaluation of the spillway was initiated as well as lowering of the reservoir pool. In addition to inspections by Grant County PUD staff, private consultants and OEP staff, an underwater inspection of the concrete monolith which contains Pier 4 was conducted by divers. On February 27th while inspecting the upstream face of the Pier 4 monolith, divers discovered structural damage in the location of an existing construction cold joint across the monolith face located about 75 feet below the water surface. The construction joint was reported to have developed into a crack with a 2 inch vertical opening and a 1-1/2 inch downstream offset. This crack extends across the entire width of the monolith. Although underwater inspections are still underway, preliminary indications are that the crack may extend through the monolith to the downstream face. As a precautionary measure, the PUD lowered the reservoir 3.5 feet beginning on February 25th and is in the process of lowering the reservoir pool further to El. 560 feet with further drawdowns possible. This will result in 11.5 feet of total drawdown. The latest alignment surveys taken over the last two days have not shown any additional movement of the spillway section. Engineers continue to evaluate the damage and appropriate corrective measures. The PUD is working to assemble a Board of Consultants to investigate the crack and movement and recommend repair options. Wanapum Dam is a high hazard potential dam and is located on the Columbia River in Kittitas County, Washington State. Both Wanapum Dam and Priest Rapids Dam are developments of the Priest Rapids Project, FERC No. 2114.

Temporary measures included installing lights onto the spillway deck so PUD staff can monitor the conditions overnight - twice daily inspections and surveys are being conducted by the PUD. The PUD has contacted the local Emergency Management Agencies to notify them of the situation and are monitoring the conditions. They are prepared to activate the Emergency Action Plan at any moment if conditions warrant. The PUD is providing daily telephone updates of the situation.

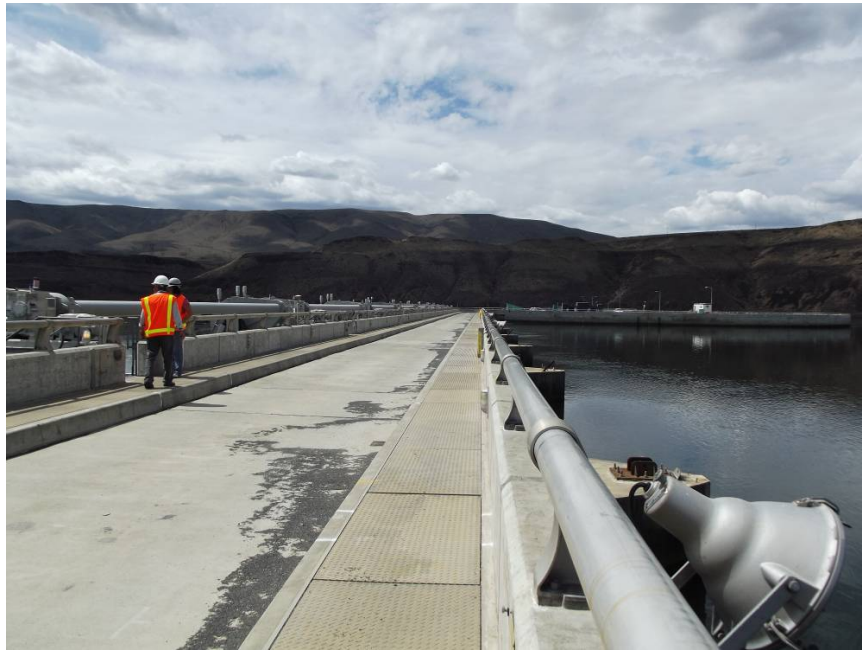
Wanapum Dam comprises left and right embankments, gravity sections, and fishways; a 10-monolith powerhouse plus a 6-monolith future unit section now infilled with concrete; and a spillway section. The spillway section (below) is an 832-foot-long reinforced concrete gravity structure containing 12 tainter gates. The stilling basin is a

level concrete apron that extends 80 feet downstream from the ogee section and terminates in a 4-foot-high end sill. The spillway deck elevation is 579.0 feet msl. .
