Fontenelle Dam, Ririe Dam, and Teton Dam

An Examination of Organizational Culture on
Decision-Making

Nate Snorteland, P.E.

U.S. Army Corps of Engineers

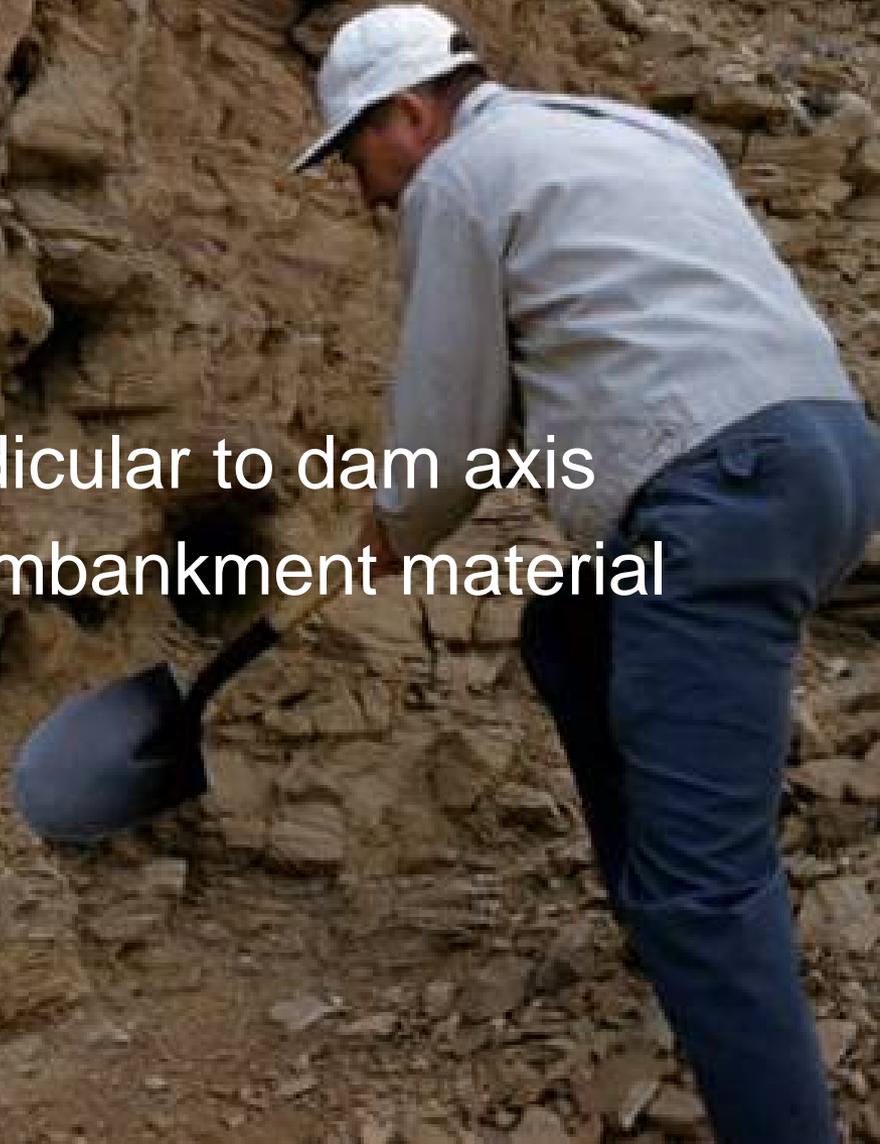
Fontenelle Construction – 1961

- Bedding plane joints
- Near vertical joints
- Near vertical relief joints
- Deep open joints perpendicular to dam axis
- Not well suited to place embankment material on

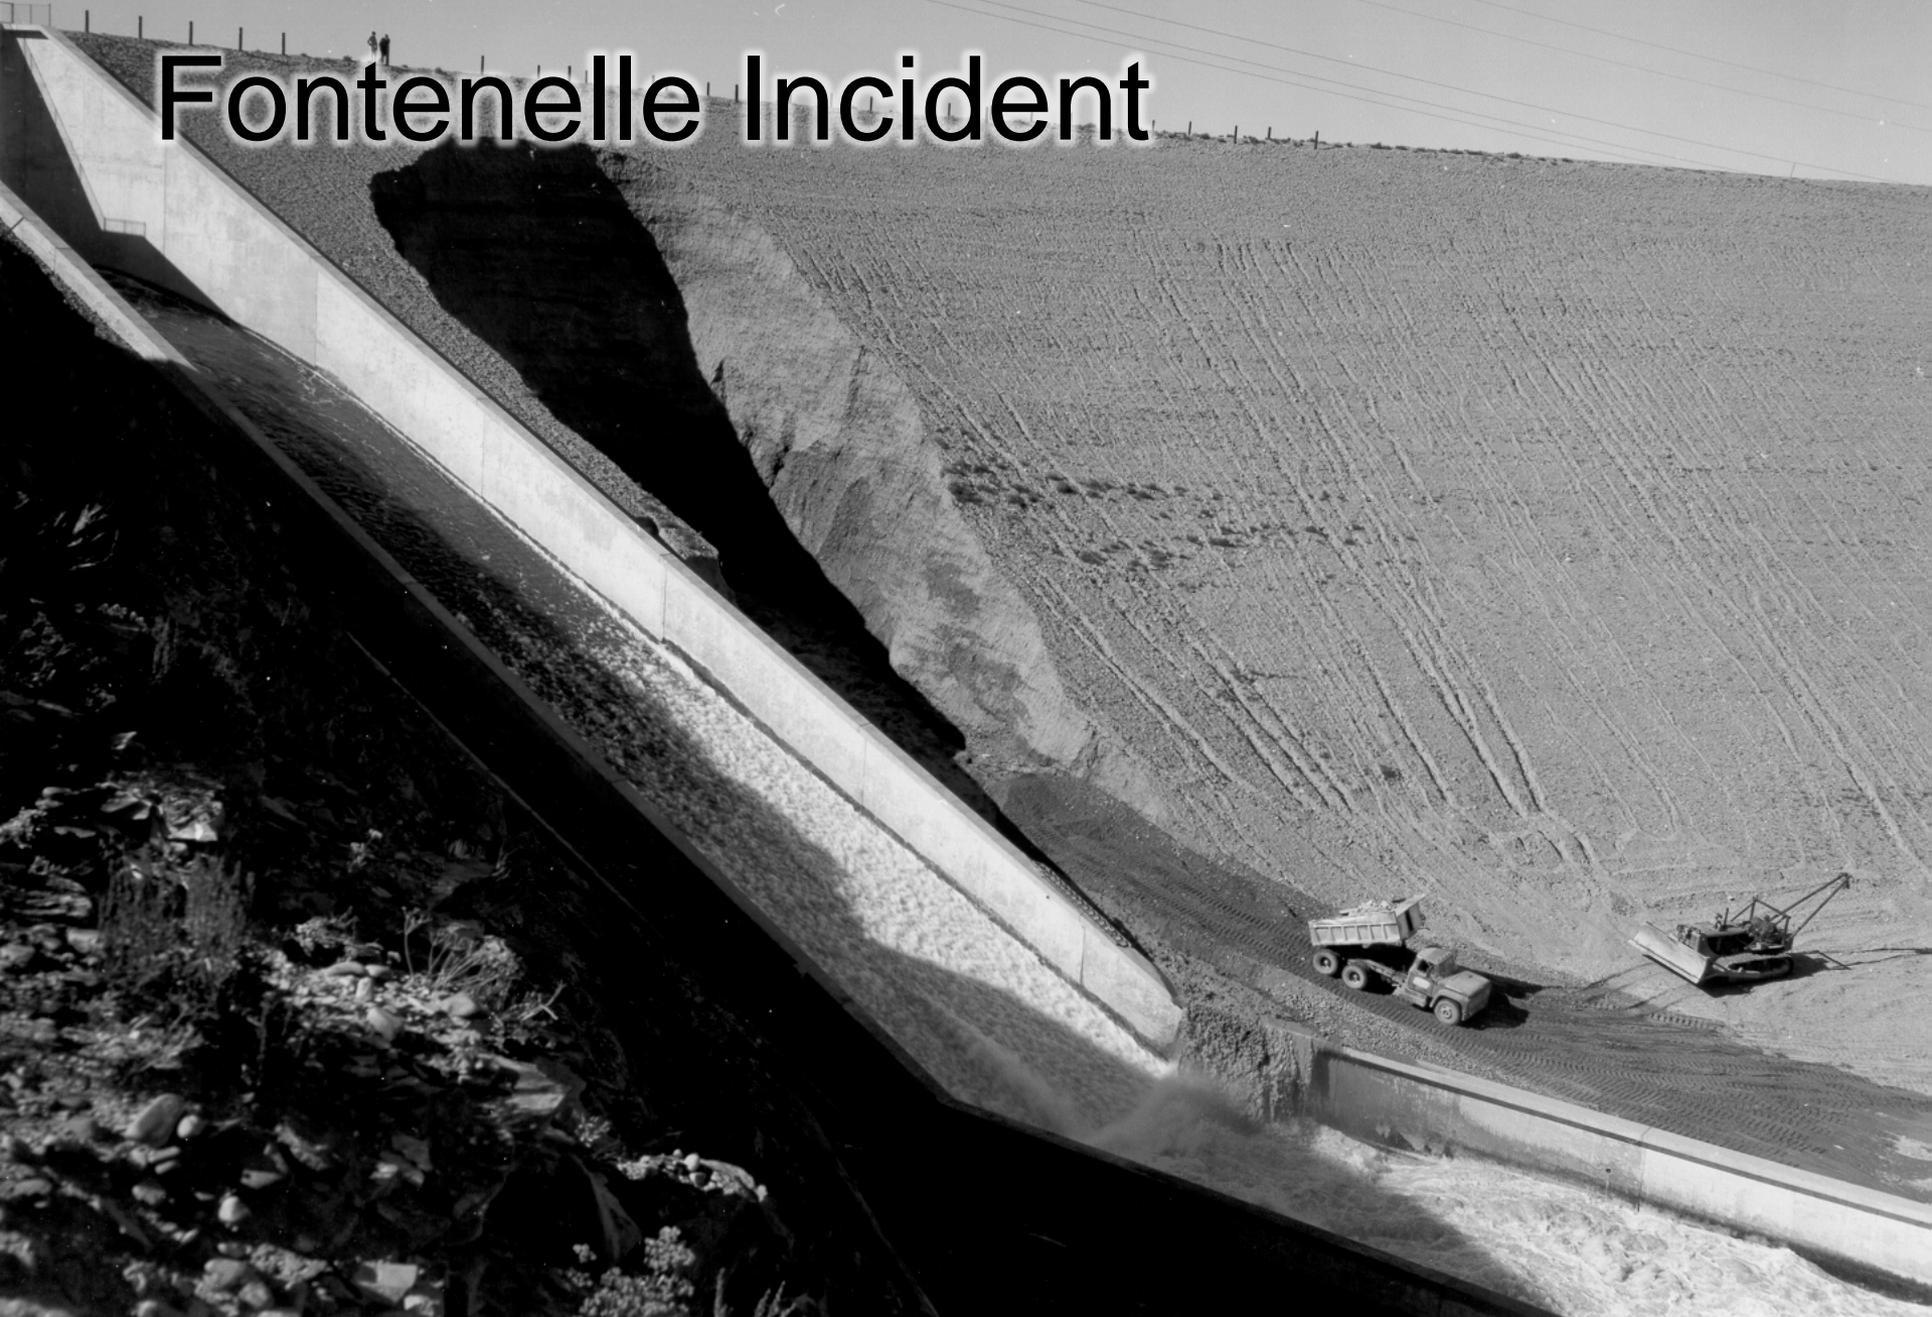
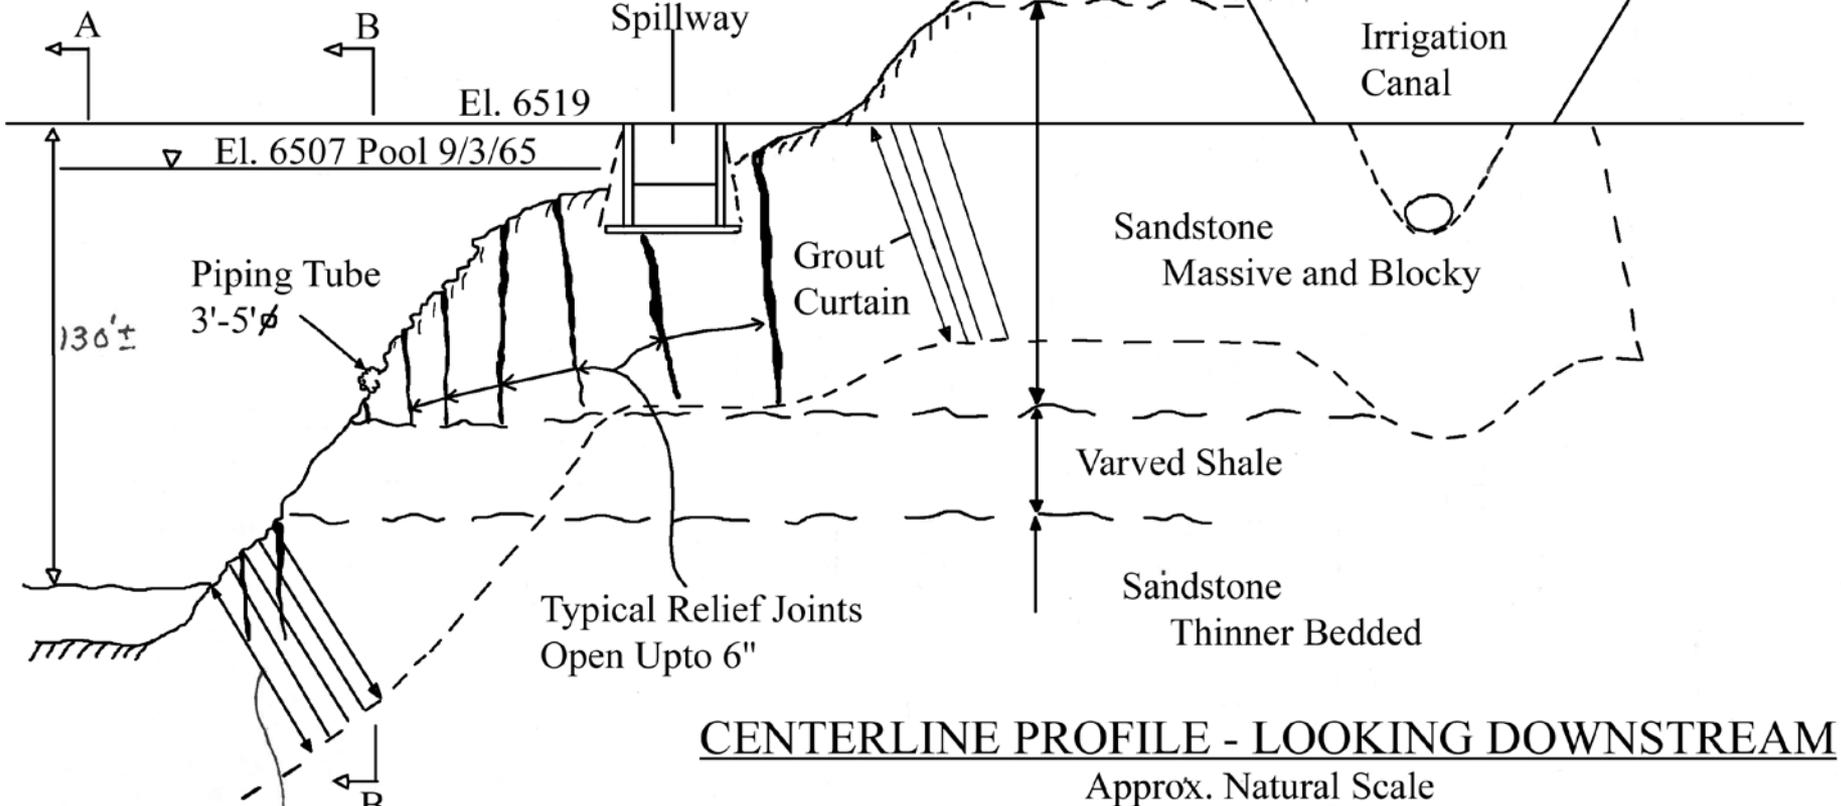
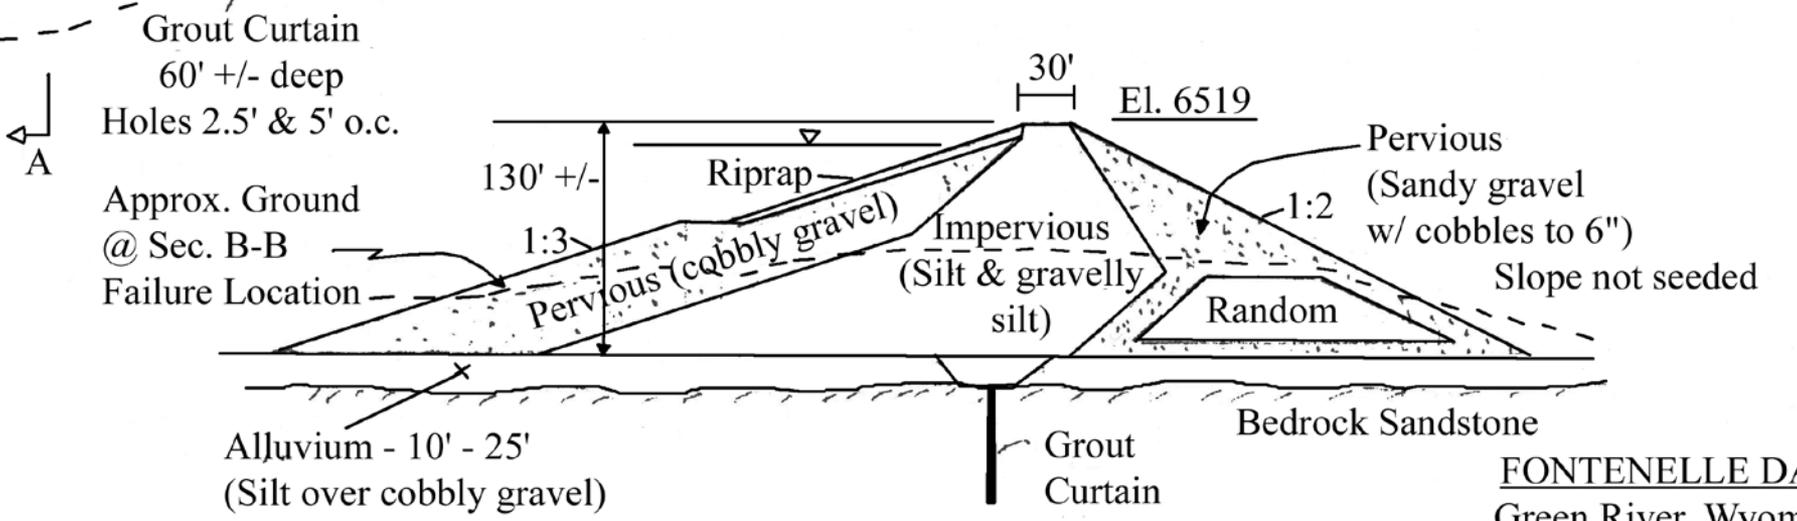
FONTENELLE DAM
Green River, Wyoming

- Essentially this is a case of **pipng through the earth embankment at its contact with the rock abutment**. It is felt seepage entered through the open relief joints in the rock and doubtless eroded soil into these open joints. Most probably the seepage jumped the grout curtain (and its 3 to 4 ft. wide concrete grout slab) by passing through looser pockets in the embankment. As the piping tube enlarged, this would attract additional seepage, accelerating erosion to cause the very severe situation shown by the enclosed ENR photo.

- Both Mr. Walker and the writer had some suspicions on the possibility of cracking in the embankment as a result of **differential settlement at this steep rock abutment** – somewhat from Corps experience at Wister and East Branch dams where cracking occurred from differential settlement and was enlarged by piping. However, it was understood that men crawled into the piping tube at Fontenelle and found no evidence of cracking in the embankment. Furthermore, the gravel to silt mixture would be less prone to cracking due to its well graded nature. In the last analysis, whether or not embankment cracking also occurred is a rather academic questions, since at best it was probably not more than an additional contributing factor to the main cause of piping at the earth-rock contact as discussed above.

- This emphasizes the policy that **designers inspecting** earthwork and foundation conditions at key times during construction is a must.
- **Fractured abutment rock** deserves very **conservative treatment**, including consolidation grouting for near full width of the core plus a conservative grout curtain (deeper than 60-foot curtain installed initially at Fontenelle).
- An irregular rock surface should be smoothed out and all overhangs removed in order to facilitate compaction of the embankment at the rock contact.
- Locating a concrete spillway close to an abutment edge is not desirable. At Fontenelle it prevented smoothing the rock surface by pre-splitting.

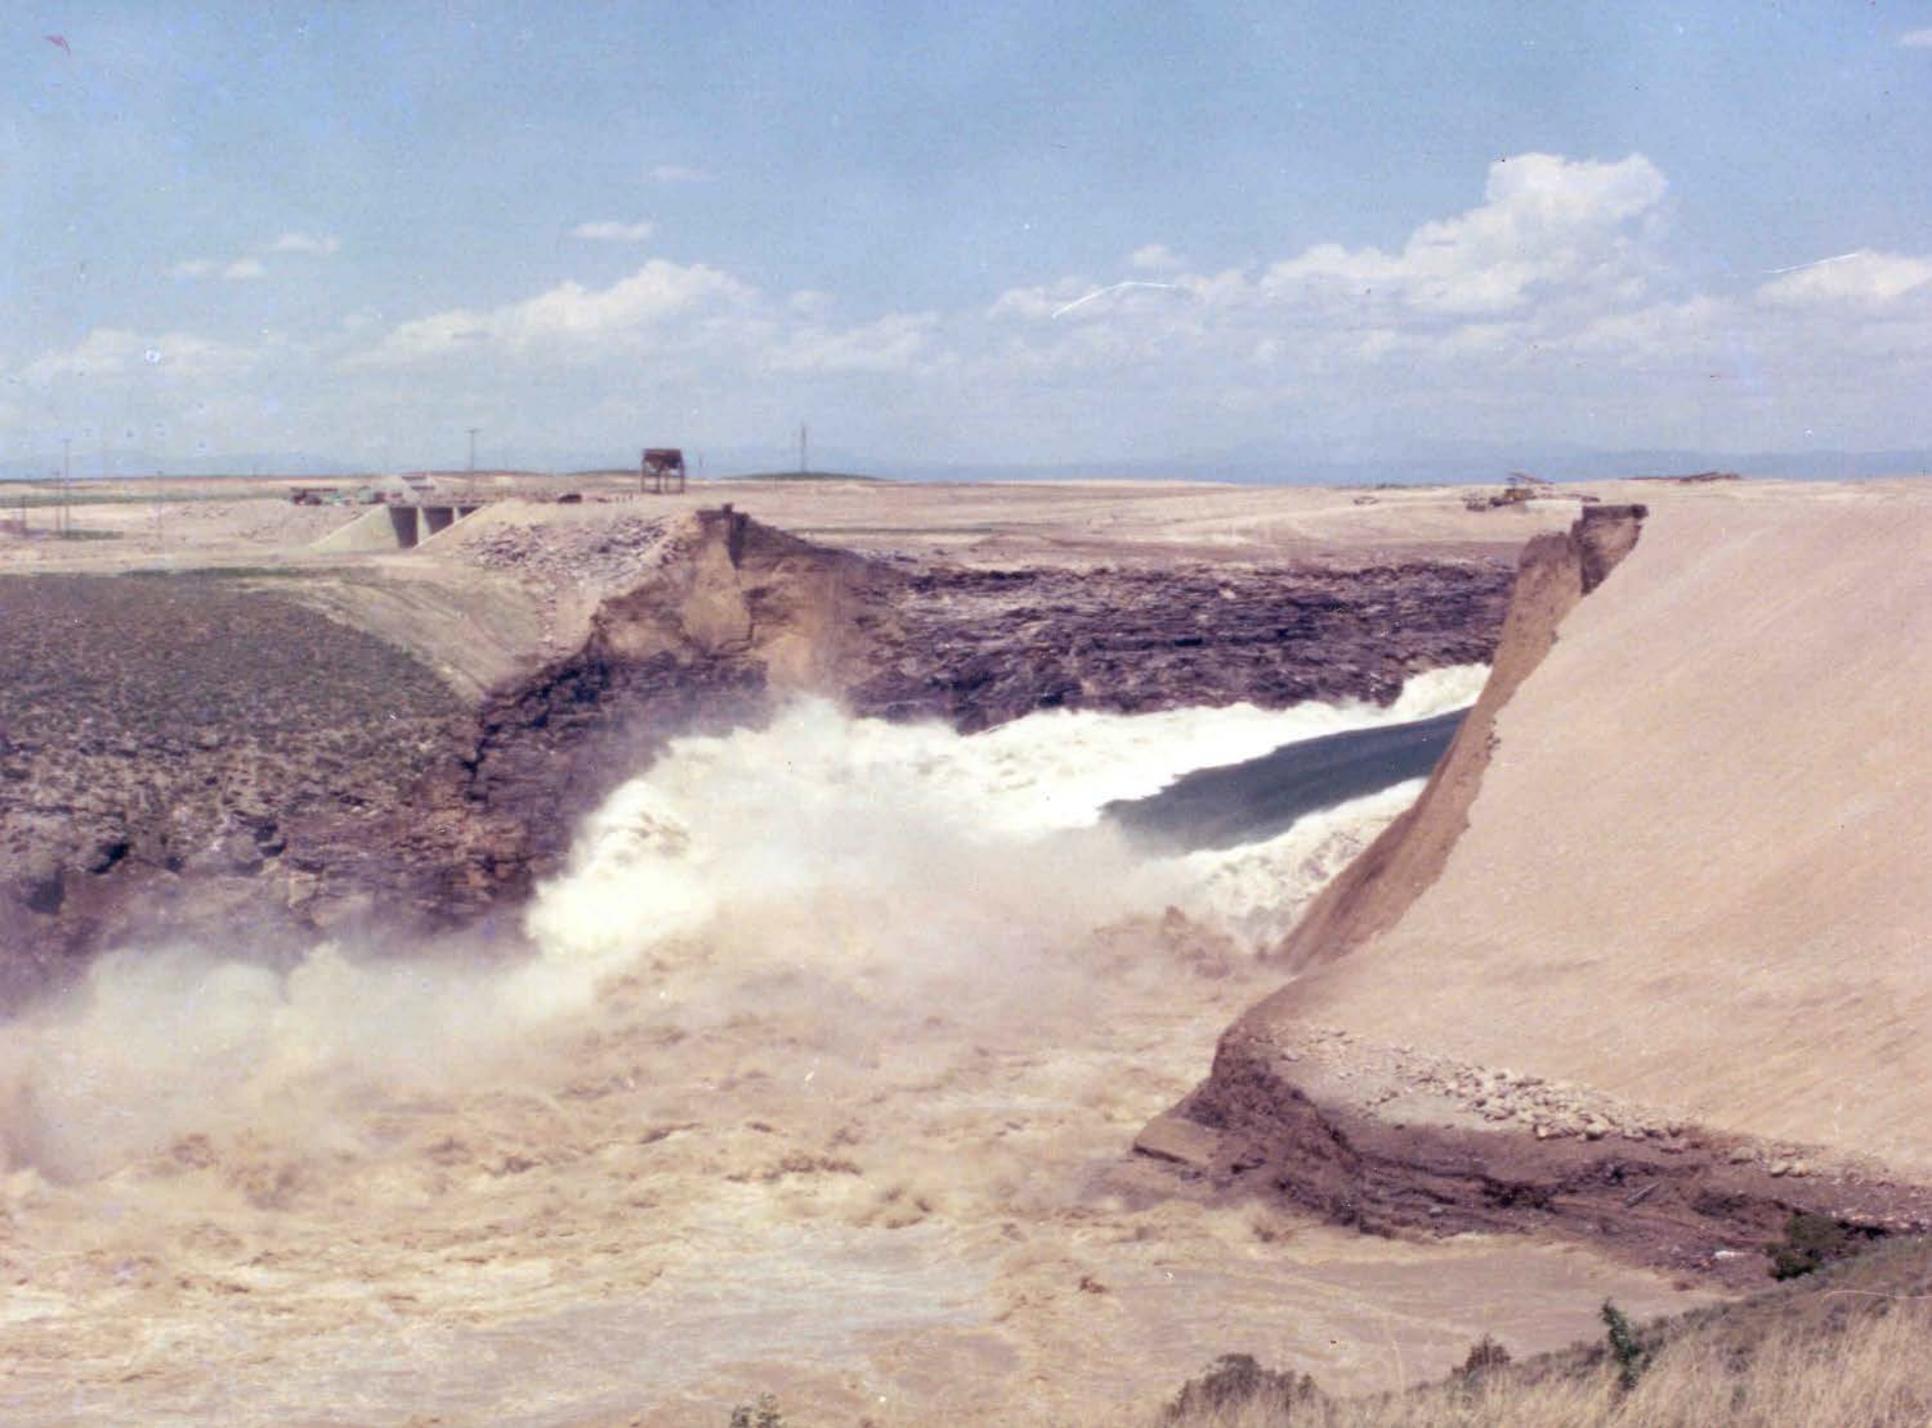
Teton Seepage

The fundamental cause of failure may be regarded as a **combination of geological factors and design decisions** that taken together permitted failure to develop
